Region 3/Solid Waste Program
Solid Waste Management Facility Site Visit Report

Facility Name/Location:	Harvest Queen Farms, T-Chester, Orange County
Date of Site Visit:	January 27, 2012
DEC Staff Present:	Steven Parisio
Others Present:	None
Background Information:	Staff received a request from Region 3/Law Enforcement to investigate the nature of fill material being placed at this site.
Purpose of Site Visit:	To determine whether the type of fill material being placed at the site is in compliance with the requirements for exempt C&D debris landfills as prescribed at 6 NYCRR 360-7.1(b)(1)(i) and to identify any environmental or regulatory compliance issues at the site.
Issues and Follow-up Required:	Some of the fill material observed at the site is natural soil and rock or C&D debris of the type allowed for disposal at exempt C&D debris landfills. Much of the fill material is C&D debris and other waste materials which are not acceptable at exempt C&D debris landfills. Problem materials included the processed C&D debris observed in several stockpiles and used to construct a road. The processed C&D debris is a problem because it contains non-exempt waste types such as dimensional lum

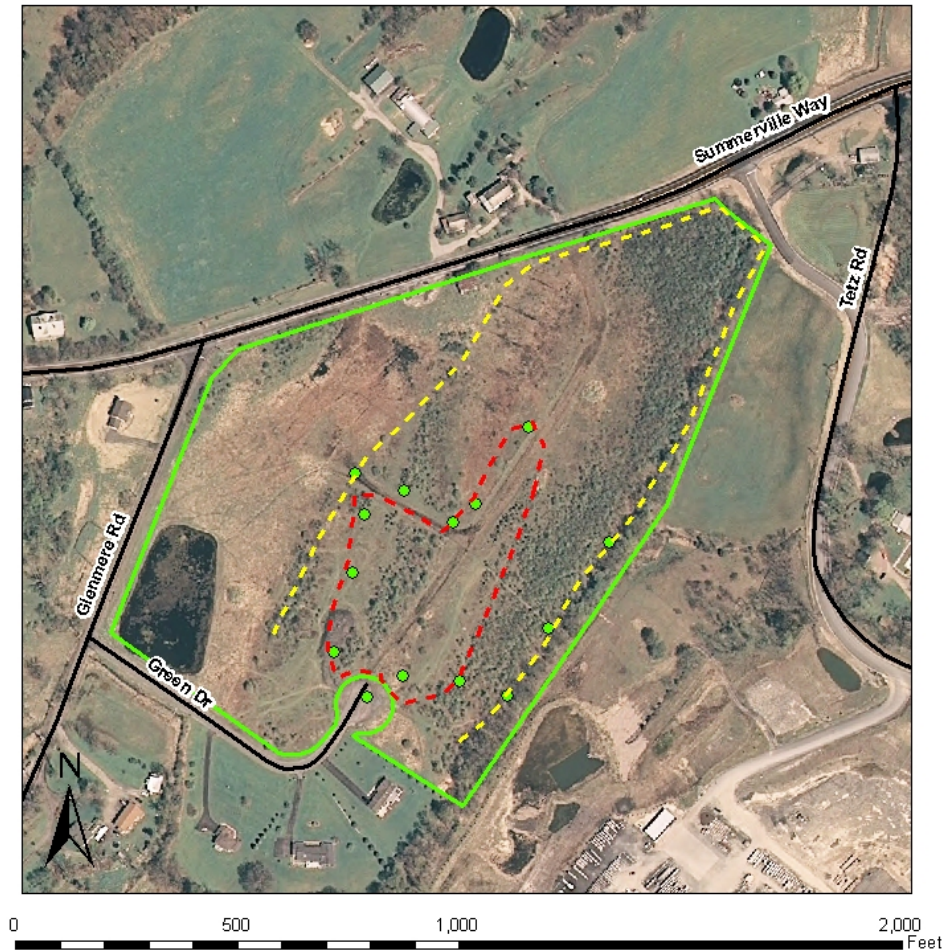
This map, prepared by staff based on GPS way points collected in the field, shows that the eastern portion of the site (approximately 15 acres) has been disturbed by clearing and grubbing operations and that the south-central portion of the site (about 3 acres) has been disturbed by stockpiling and placement of fill material.

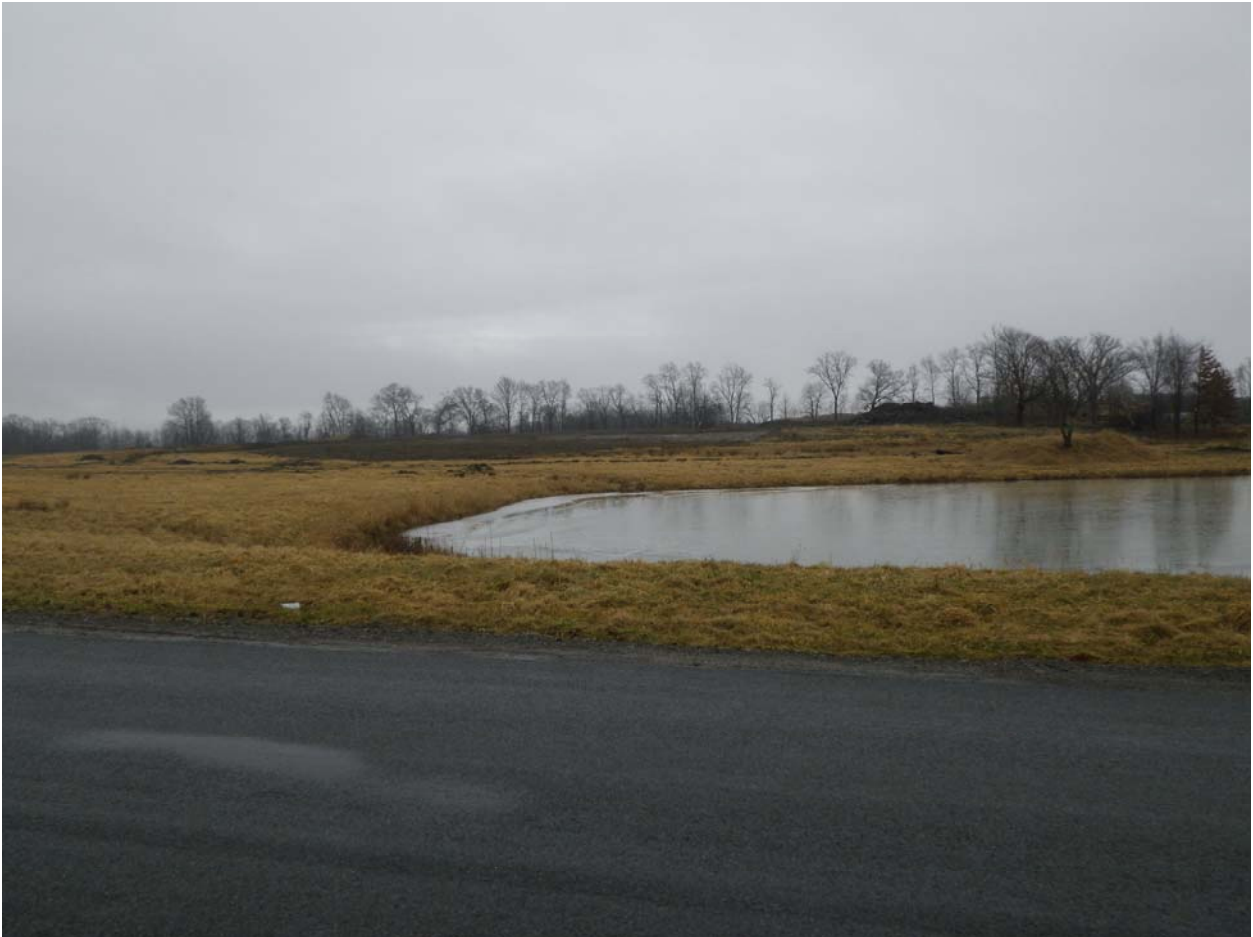
The western portion of the site, including the area surrounding the pond, was not disturbed at the time of this site visit.

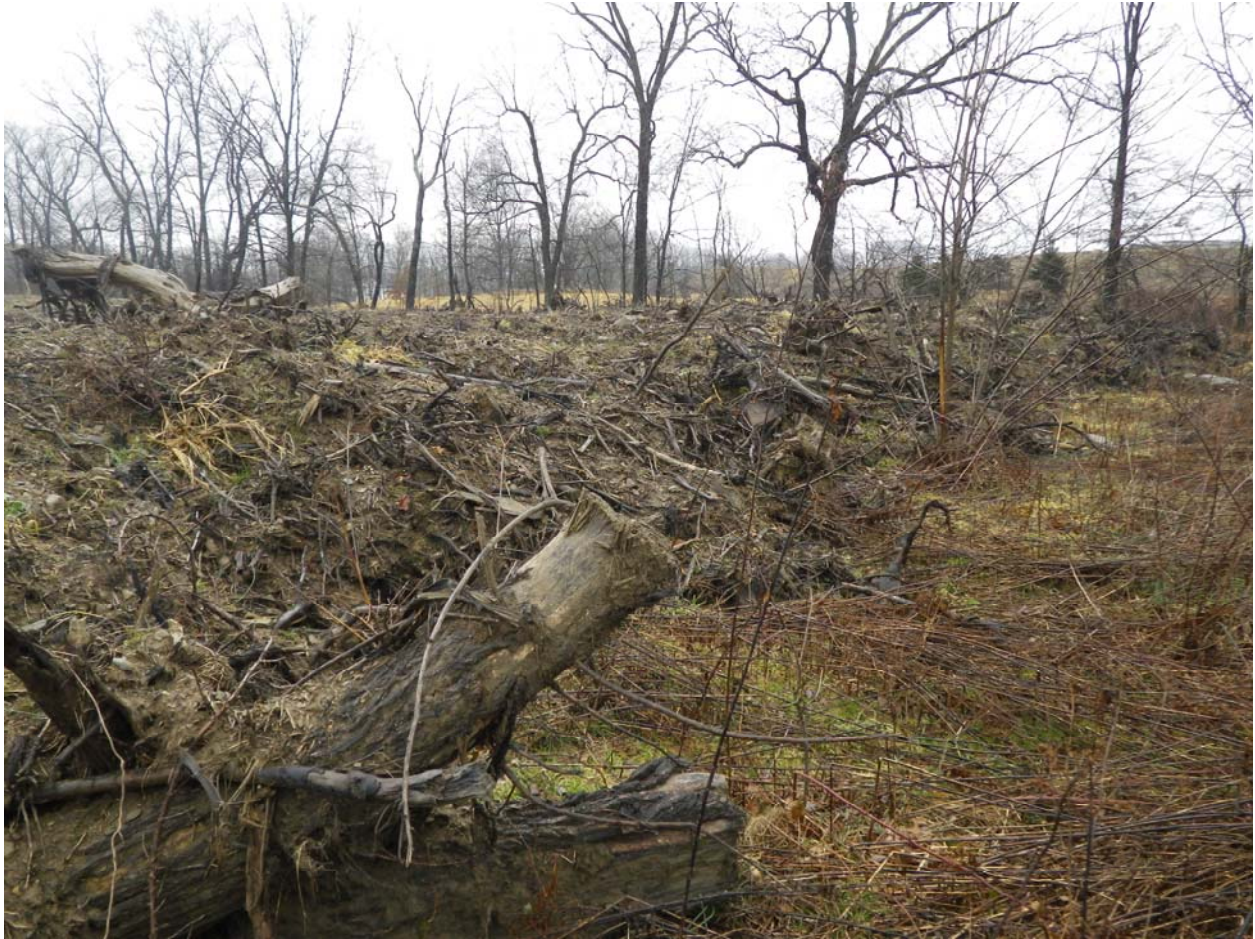
This photo, taken in the southeast portion of the site, shows some of the area disturbed by clearing and grubbing.

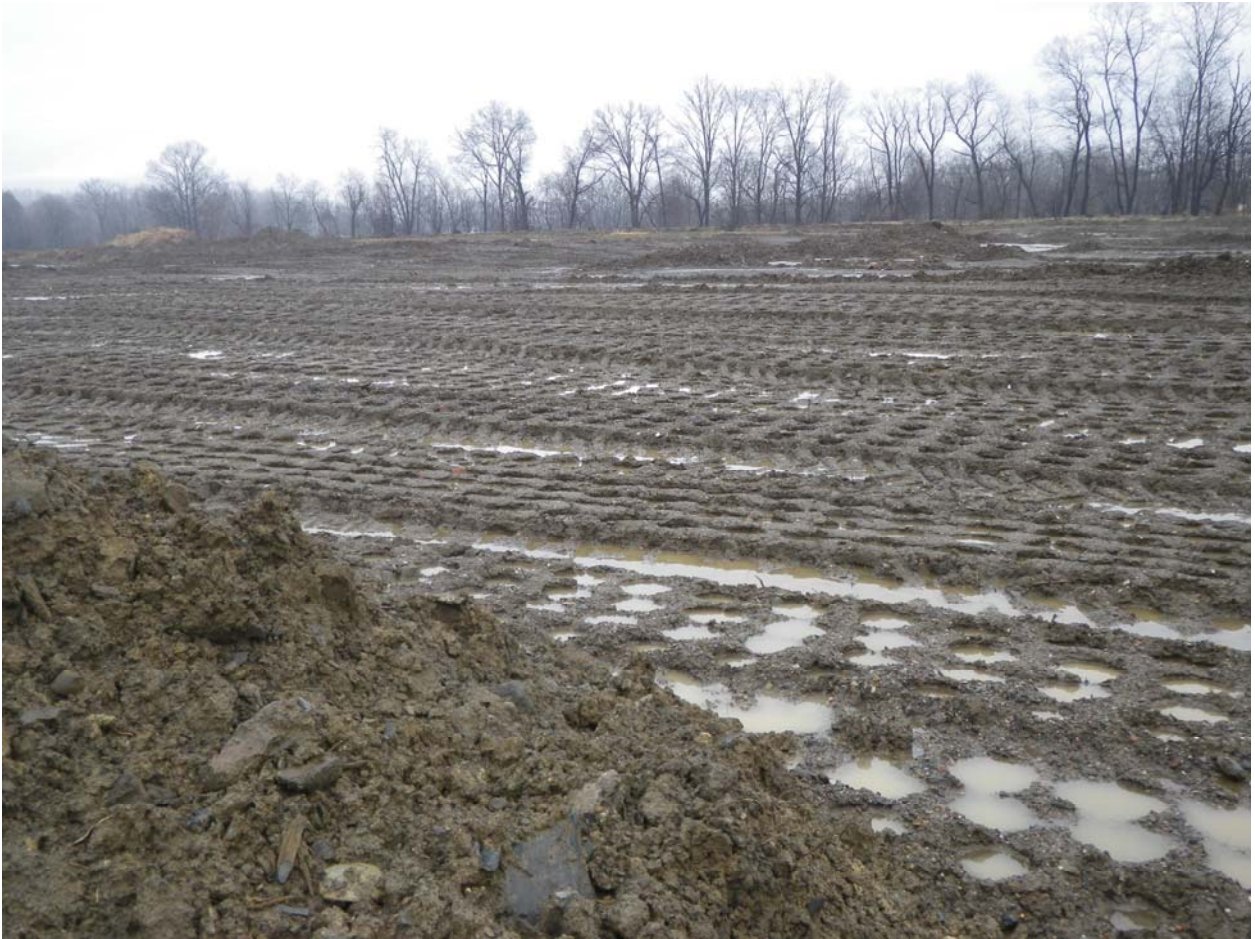
The south-central area of the site where fill material has been placed, spread and compacted using a Sheepsfoot roller.

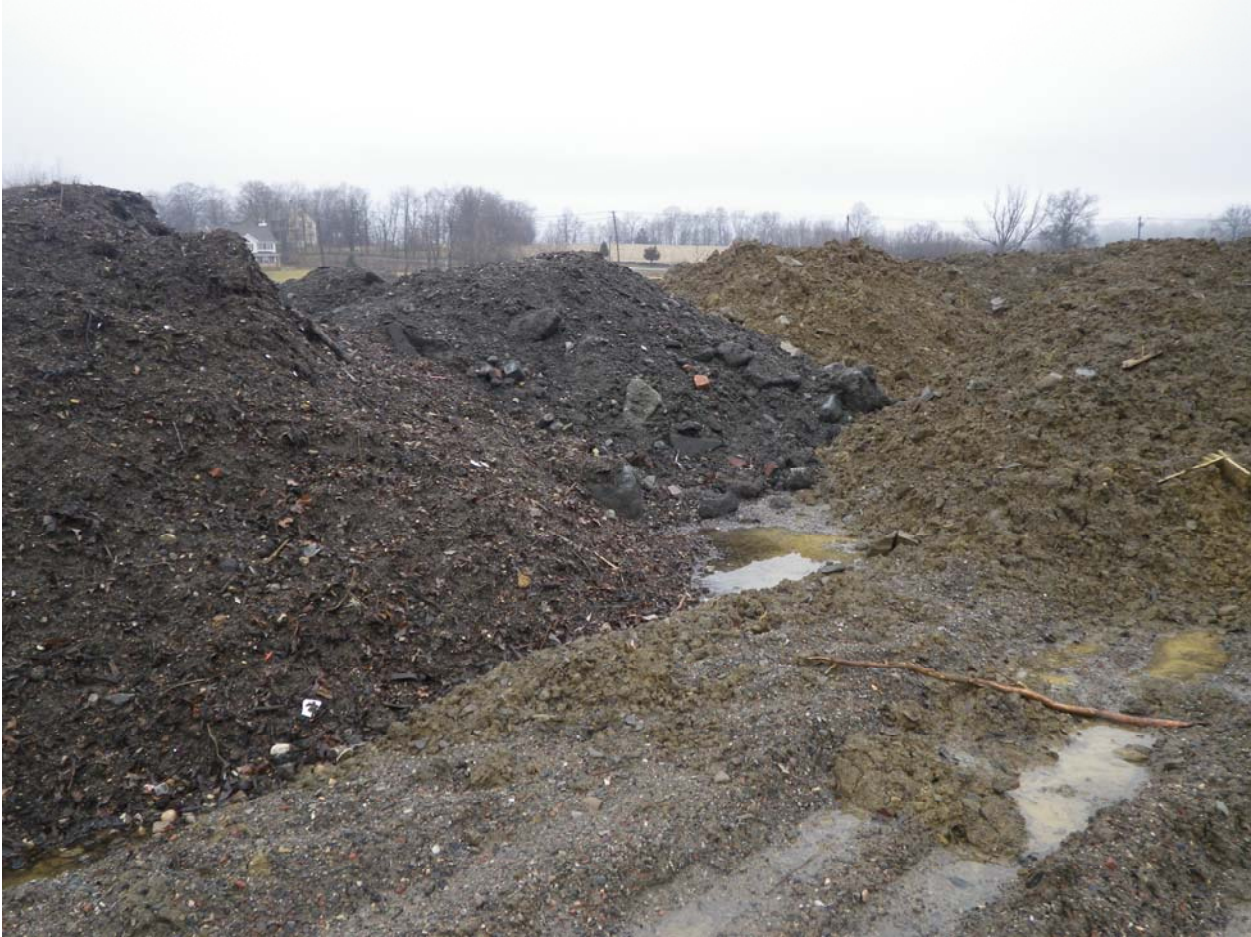
Portions of the site are covered with fill material stockpiles which have not been spread. This photo shows three different types of materials. The pile on the left is a mixture of leaves and other organic wastes with C&D debris and trash. The pile in the middle is C&D debris in a dark soil-like matrix. The piles on the right are a mixture of natural soils (strong brown color) and natural rock fragments.

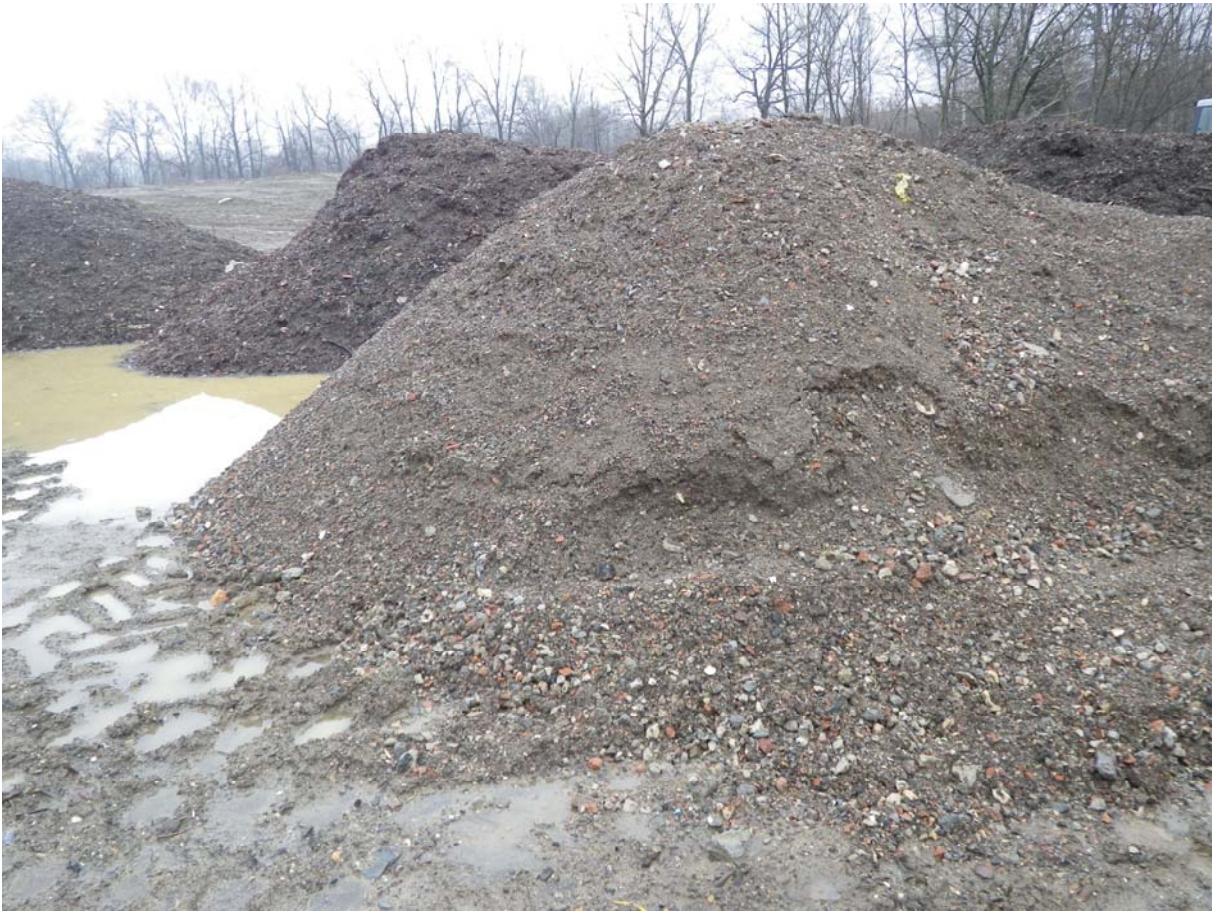
A pile of processed C&D debris which was one of several observed on the site.

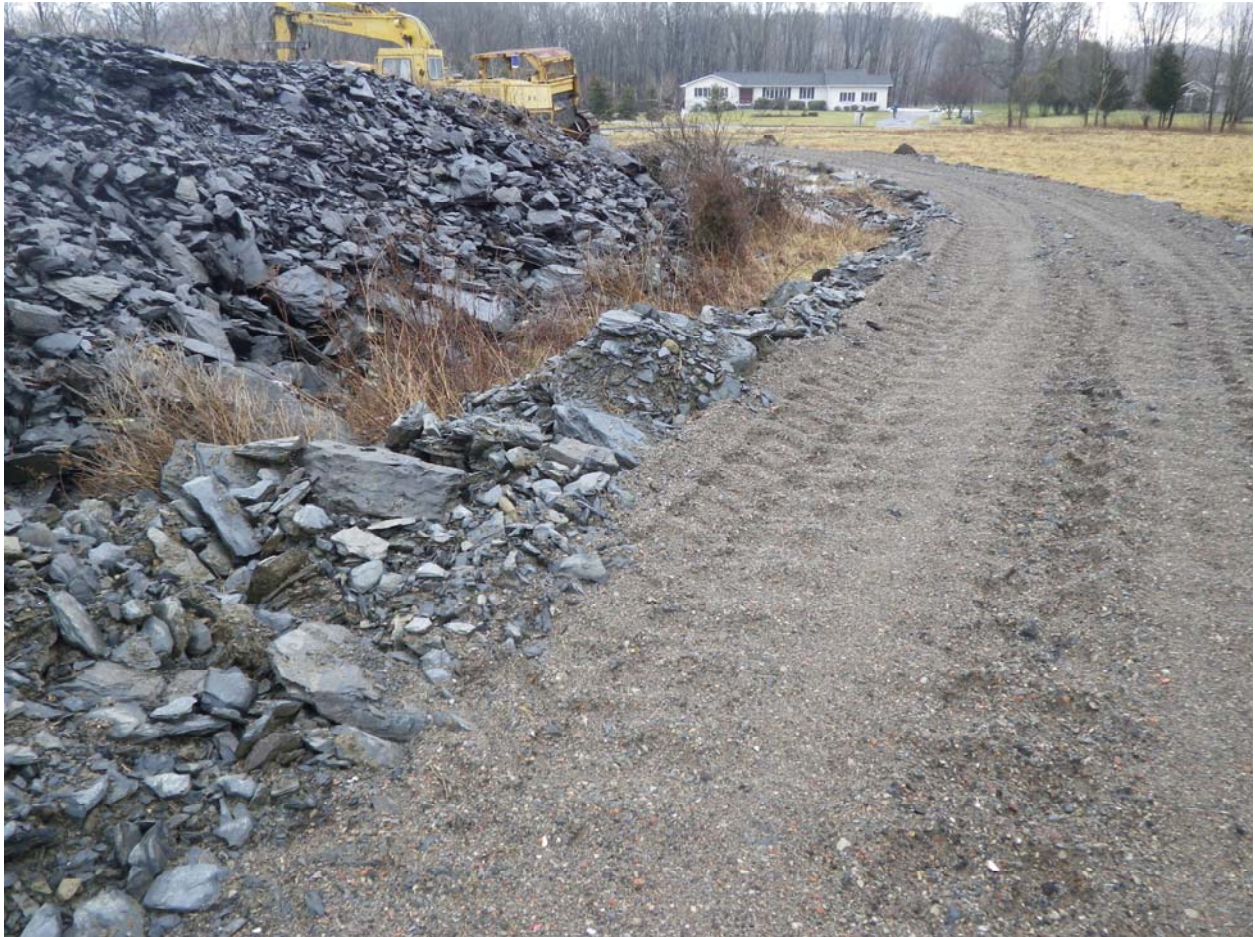
A road constructed using (imported) processed C&D debris. The pile of natural rock on the left appears to have been generated from excavation of materials native to the site.

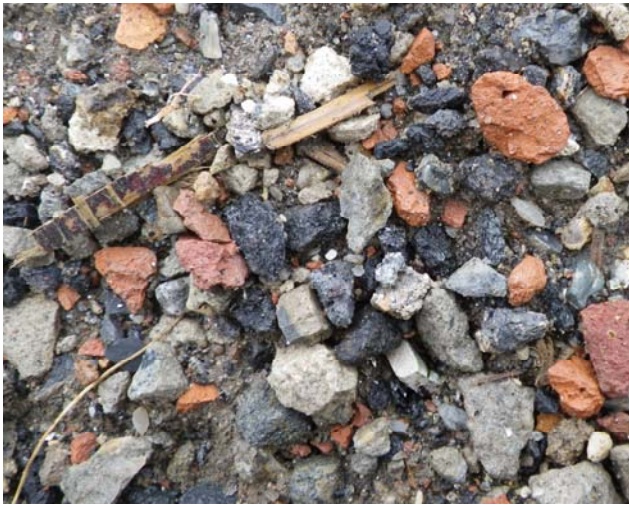
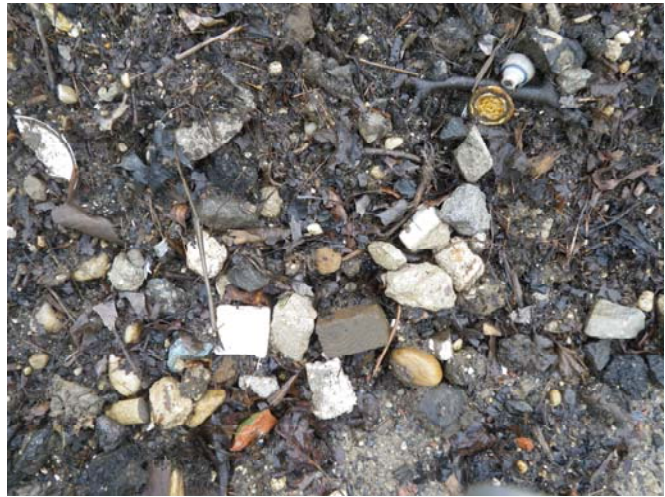
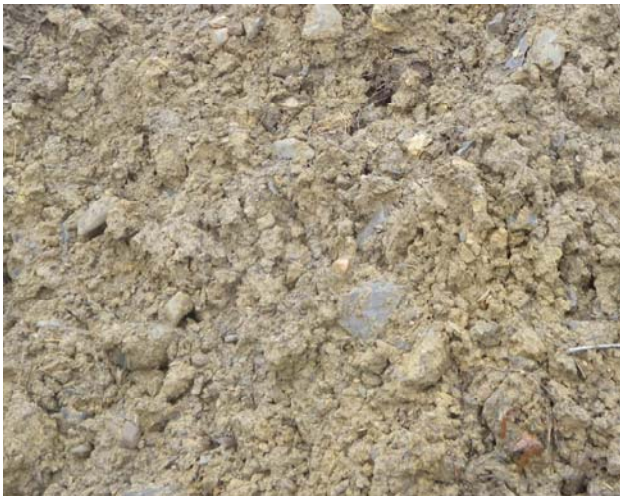
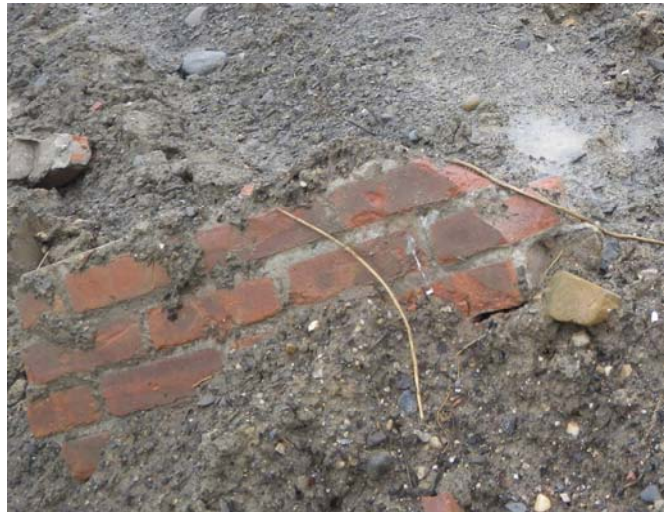
Close-up photos showing different types of fill material observed at the site. Clockwise from upper left: processed C&D debris, leaves commingled with trash and C&D debris, unprocessed building demolition debris and natural soil with natural rock.
