Region 3/Solid Waste Program
Solid Waste Management Facility Site Visit Report

Facility Name/Location:	Harvest Queen Farms, T-Chester, Orange County
Date of Site Visit:	March 14, 2012
DEC Staff Present:	Steven Parisio Galyna Klishch
Persons Interviewed:	Jeremy R. Valentine, consultant Mr. Kocot, property owner
Background Information:	This is a site which received fill material of questionable quality including C&D debris. The property owner has hired a consultant to sample the fill material to determine whether or not it contains contamination at levels which pose a risk to the environment.
Purpose of Site Visit:	To oversee collection of fill samples for chemical testing by the site owner's consultant.
New Issues and Follow-up Required:	Observations regarding the type and extent of fill material at the site were consistent with what was observed during the previous (January 27, 2012) site visit. Many of the fill stockpiles had been removed but several still remained including one pile of processed C&D debris and another pile of C&D debris commingled with a dark colored soil. Seven test pits were excavated focusing on areas where C&D debris was most evident (with the exception of t

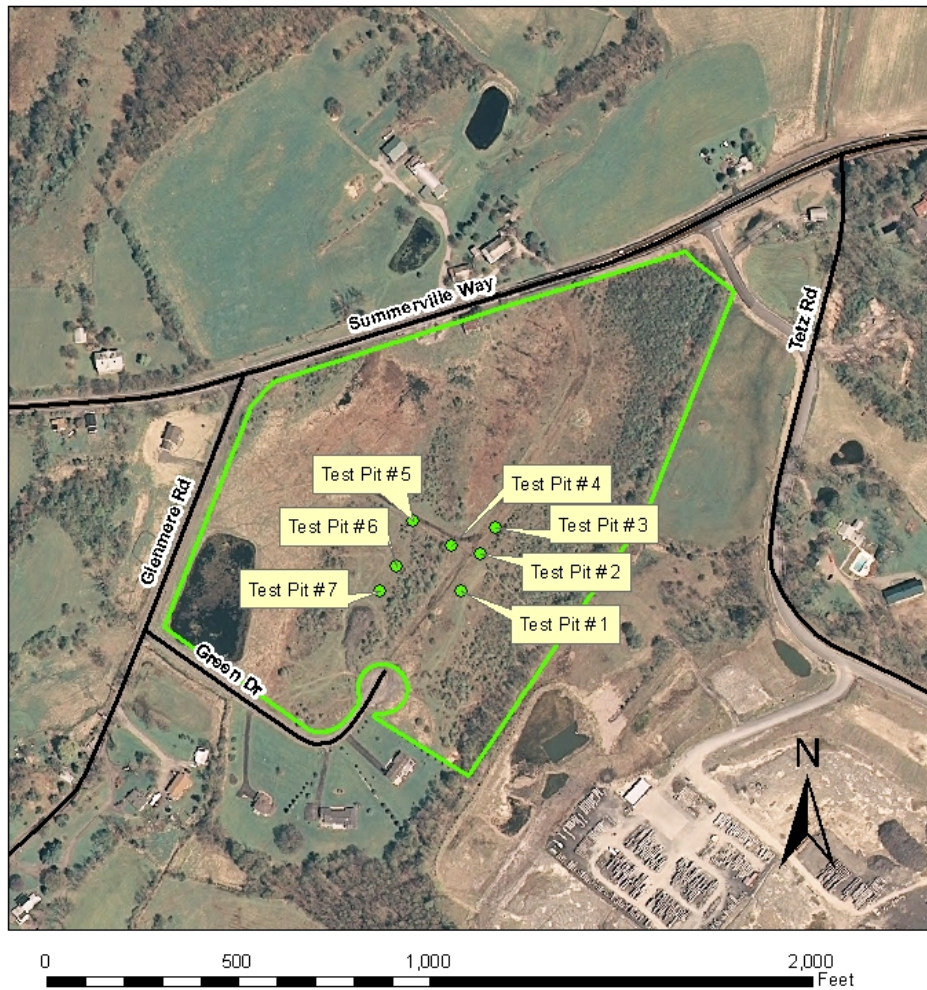
This map was prepared using GPS waypoints collected at the site to show the locations of seven test pits which were excavated to allow observation and sampling of the fill material.

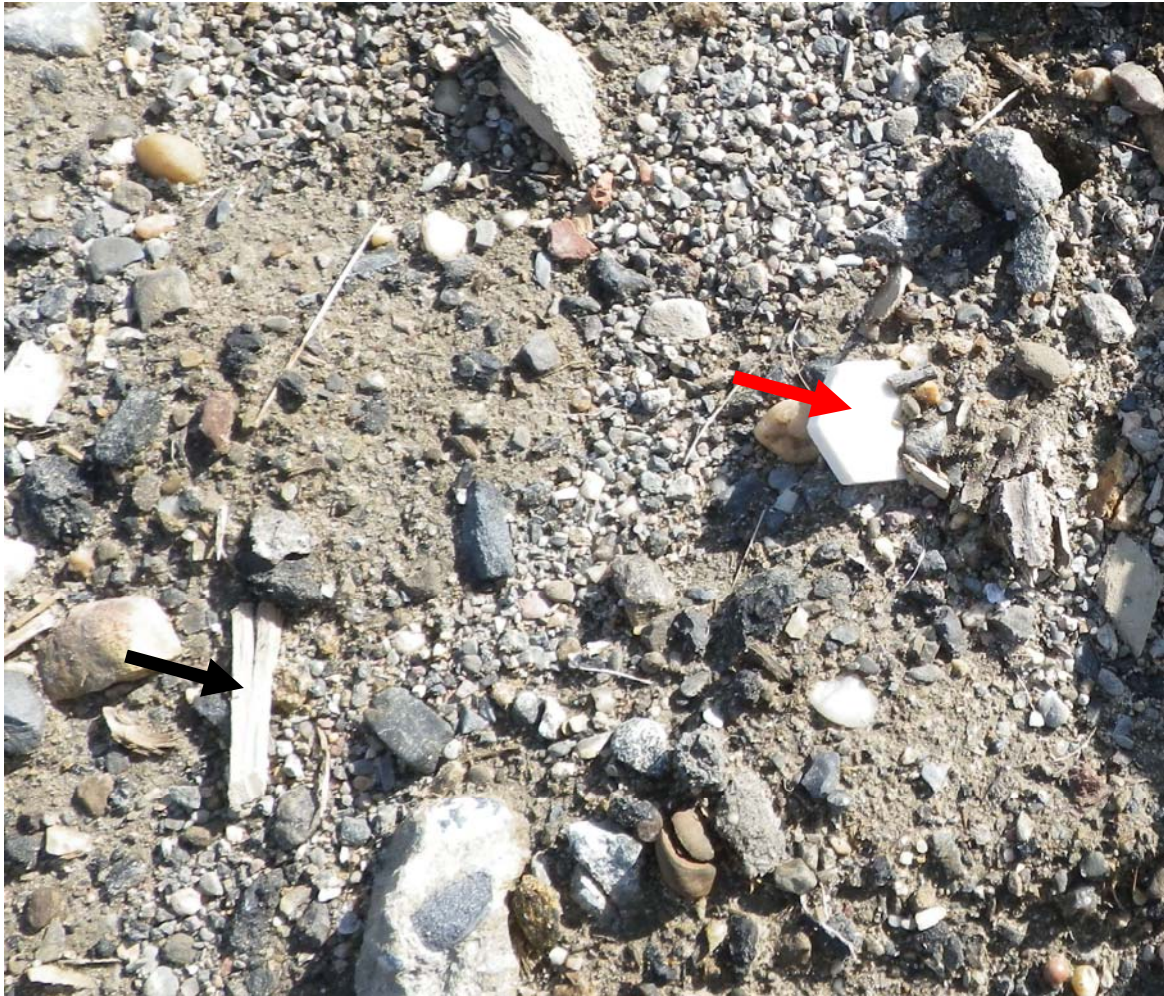
Prior to excavation of test pits, we walked over the portion of the site which has been filled and we selected test pit locations based on waste material observed at the surface. This photo shows the surface at the location of the first test pit (Test Pit #1) which was selected because it showed evidence of C&D debris including ceramic tile (red arrow), dimensional lumber (black arrow) and concrete.

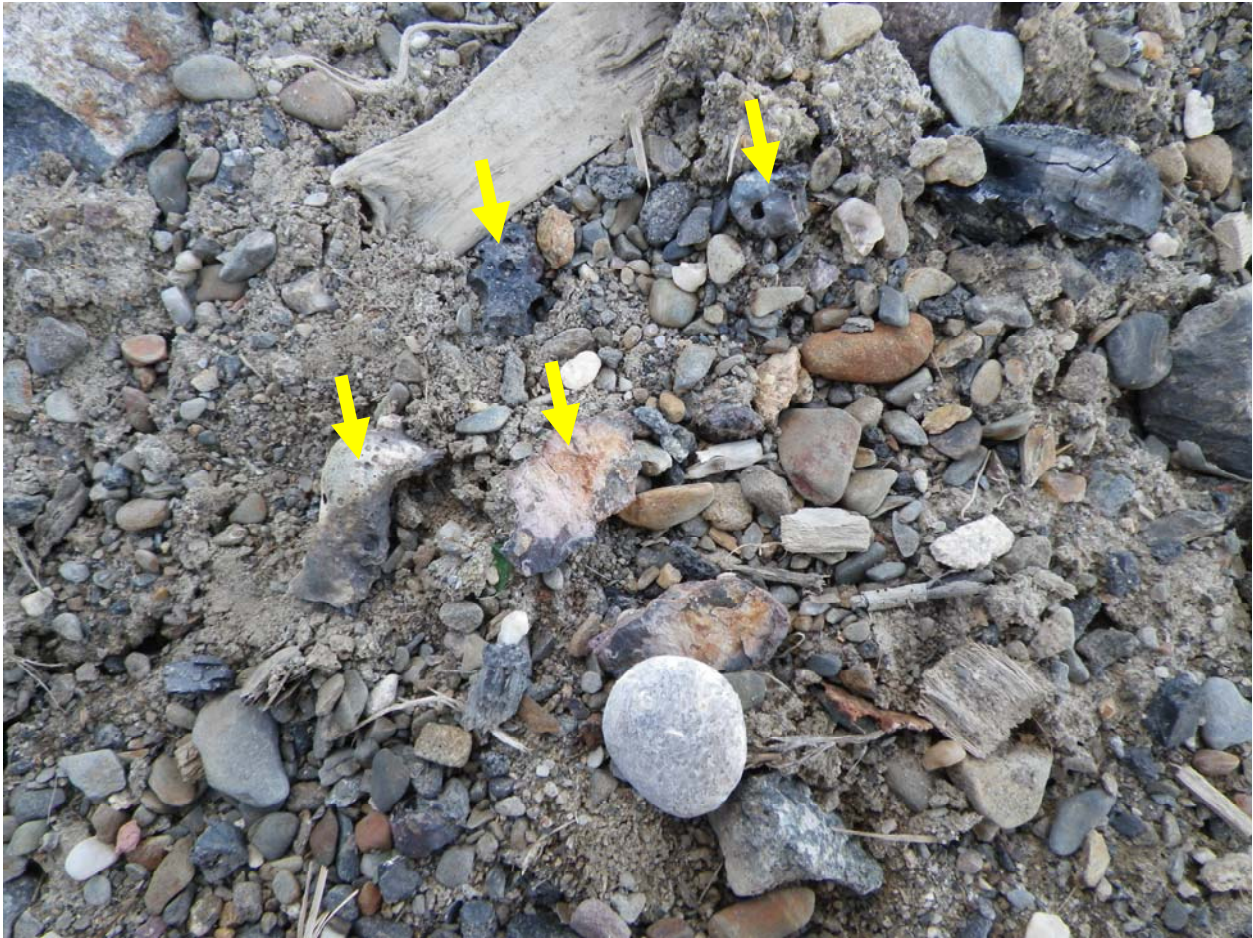
The location for the second test pit was selected based on a high concentration of coal combustion bottom ash (yellow arrows) observed at the surface.

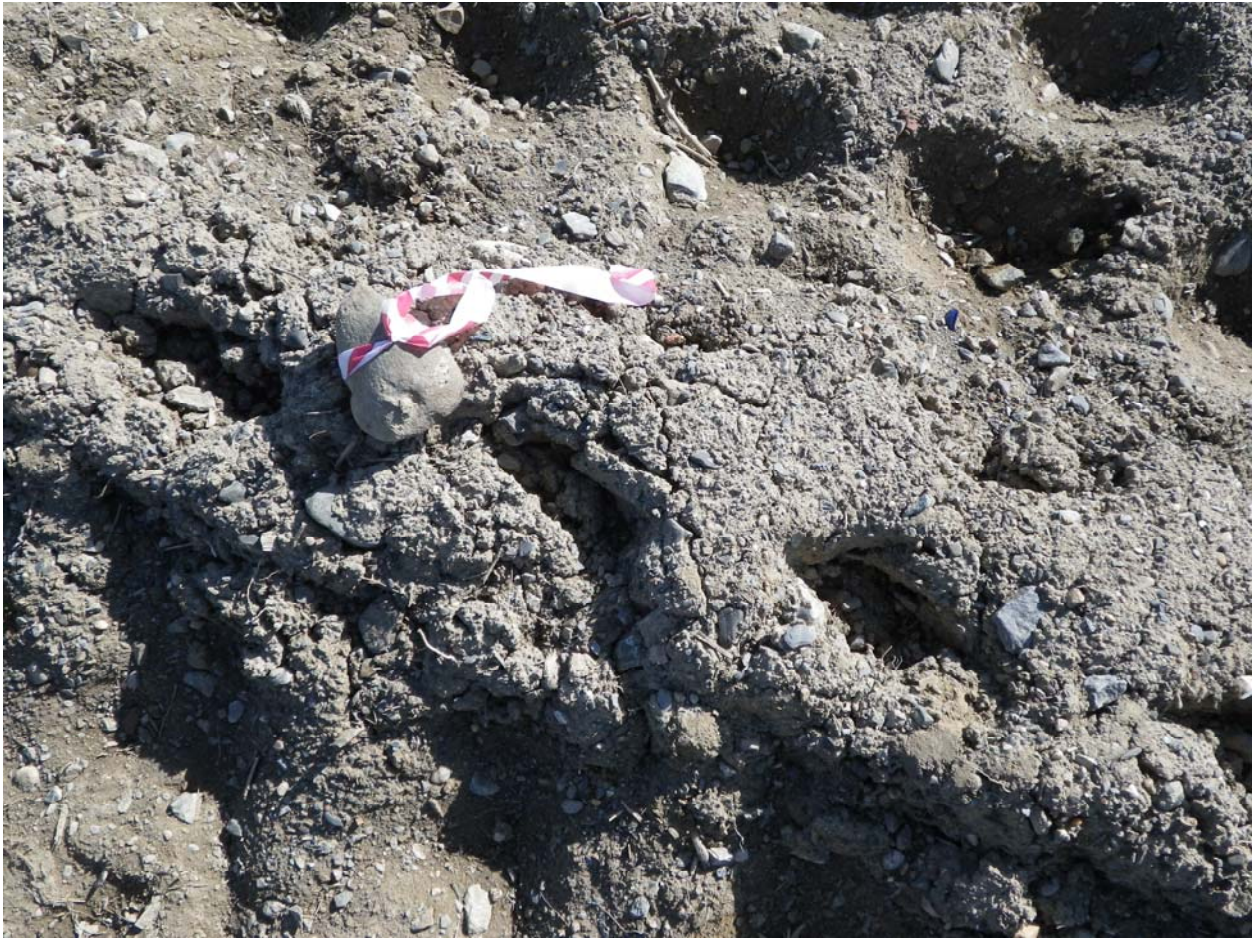
Test pit 5 was excavated in an area where fill material had been spread and compacted (note evidence of Sheepsfoot roller in this photo) but the fill material at the surface consisted of natural soil and rock with no evidence of C&D debris. \

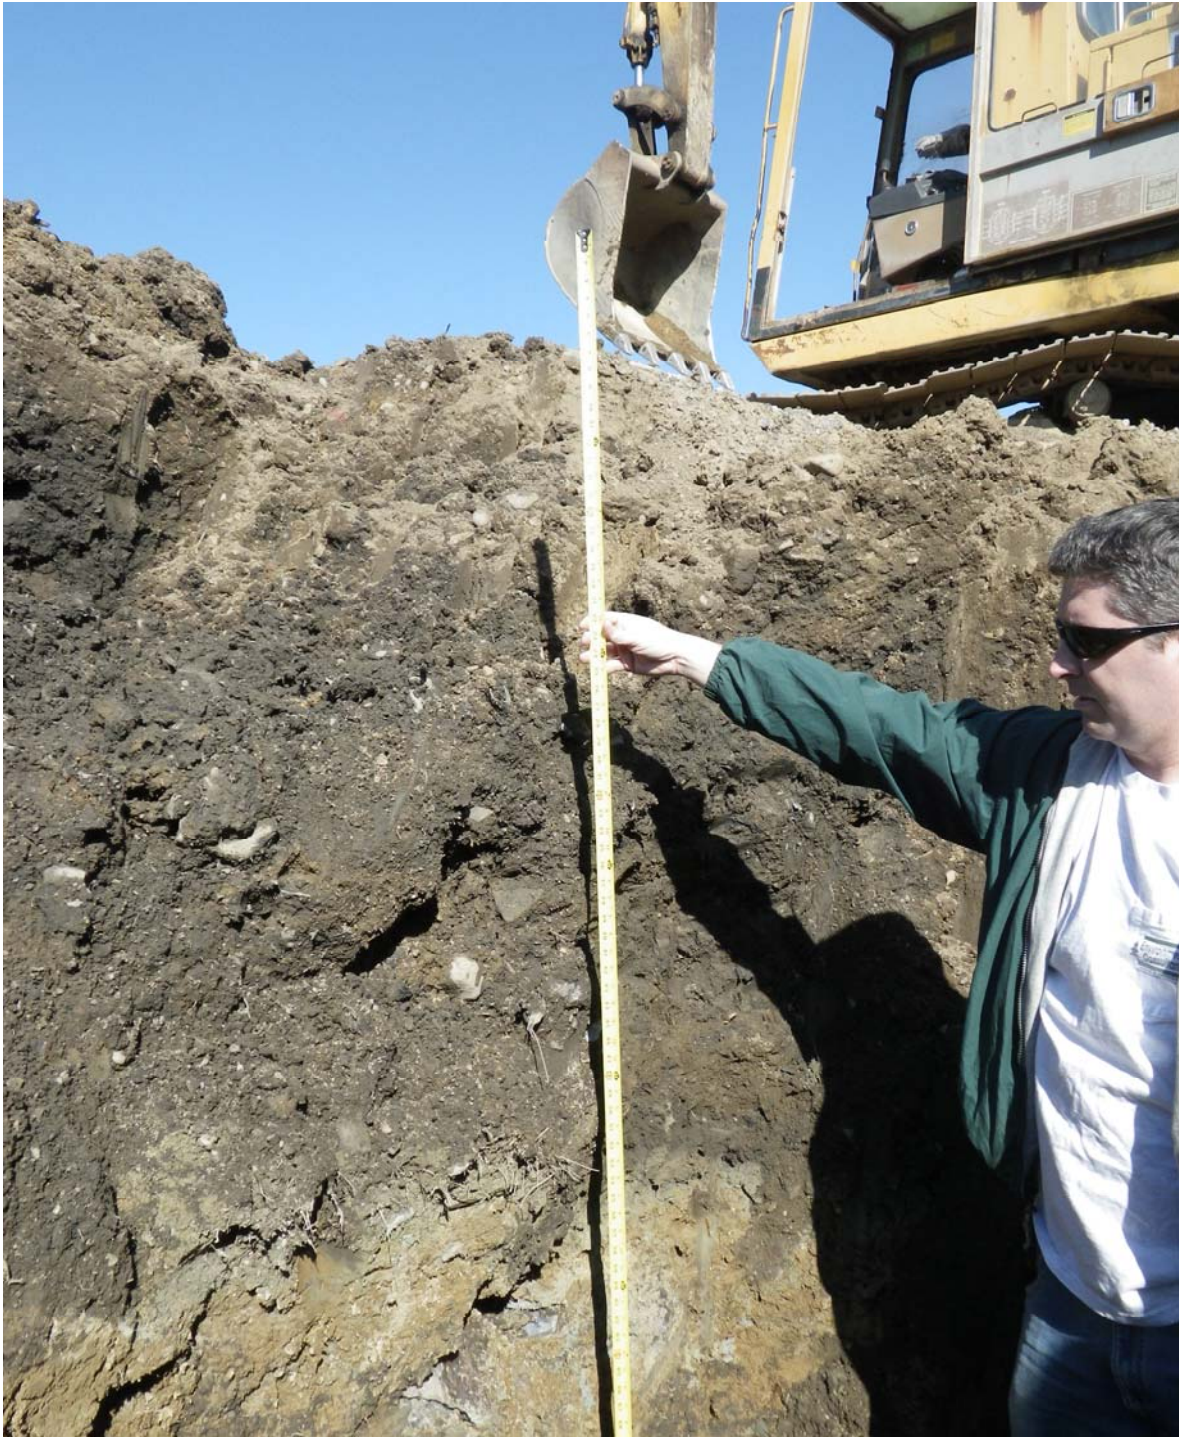
Test Pit #2 showed a layer of fill material from 0 to 52 inches with a very dark grayish brown color (10 YR 3/2) in the soil matrix. The native soil below had a pale low chroma color contrasting sharply with the fill and indicative of seasonally wet conditions. Sample 2 was taken at a depth of 36 to 48 inches in this test pit. This test pit had the thickest layer of fill material compared to other test pits.
