**TIM  
MILLER  
ASSOCIATES, INC.**

November 2, 2015

Re: **Primo Sports Athletic Field Noise and Lighting Assessment  
Town of Chester, NY**

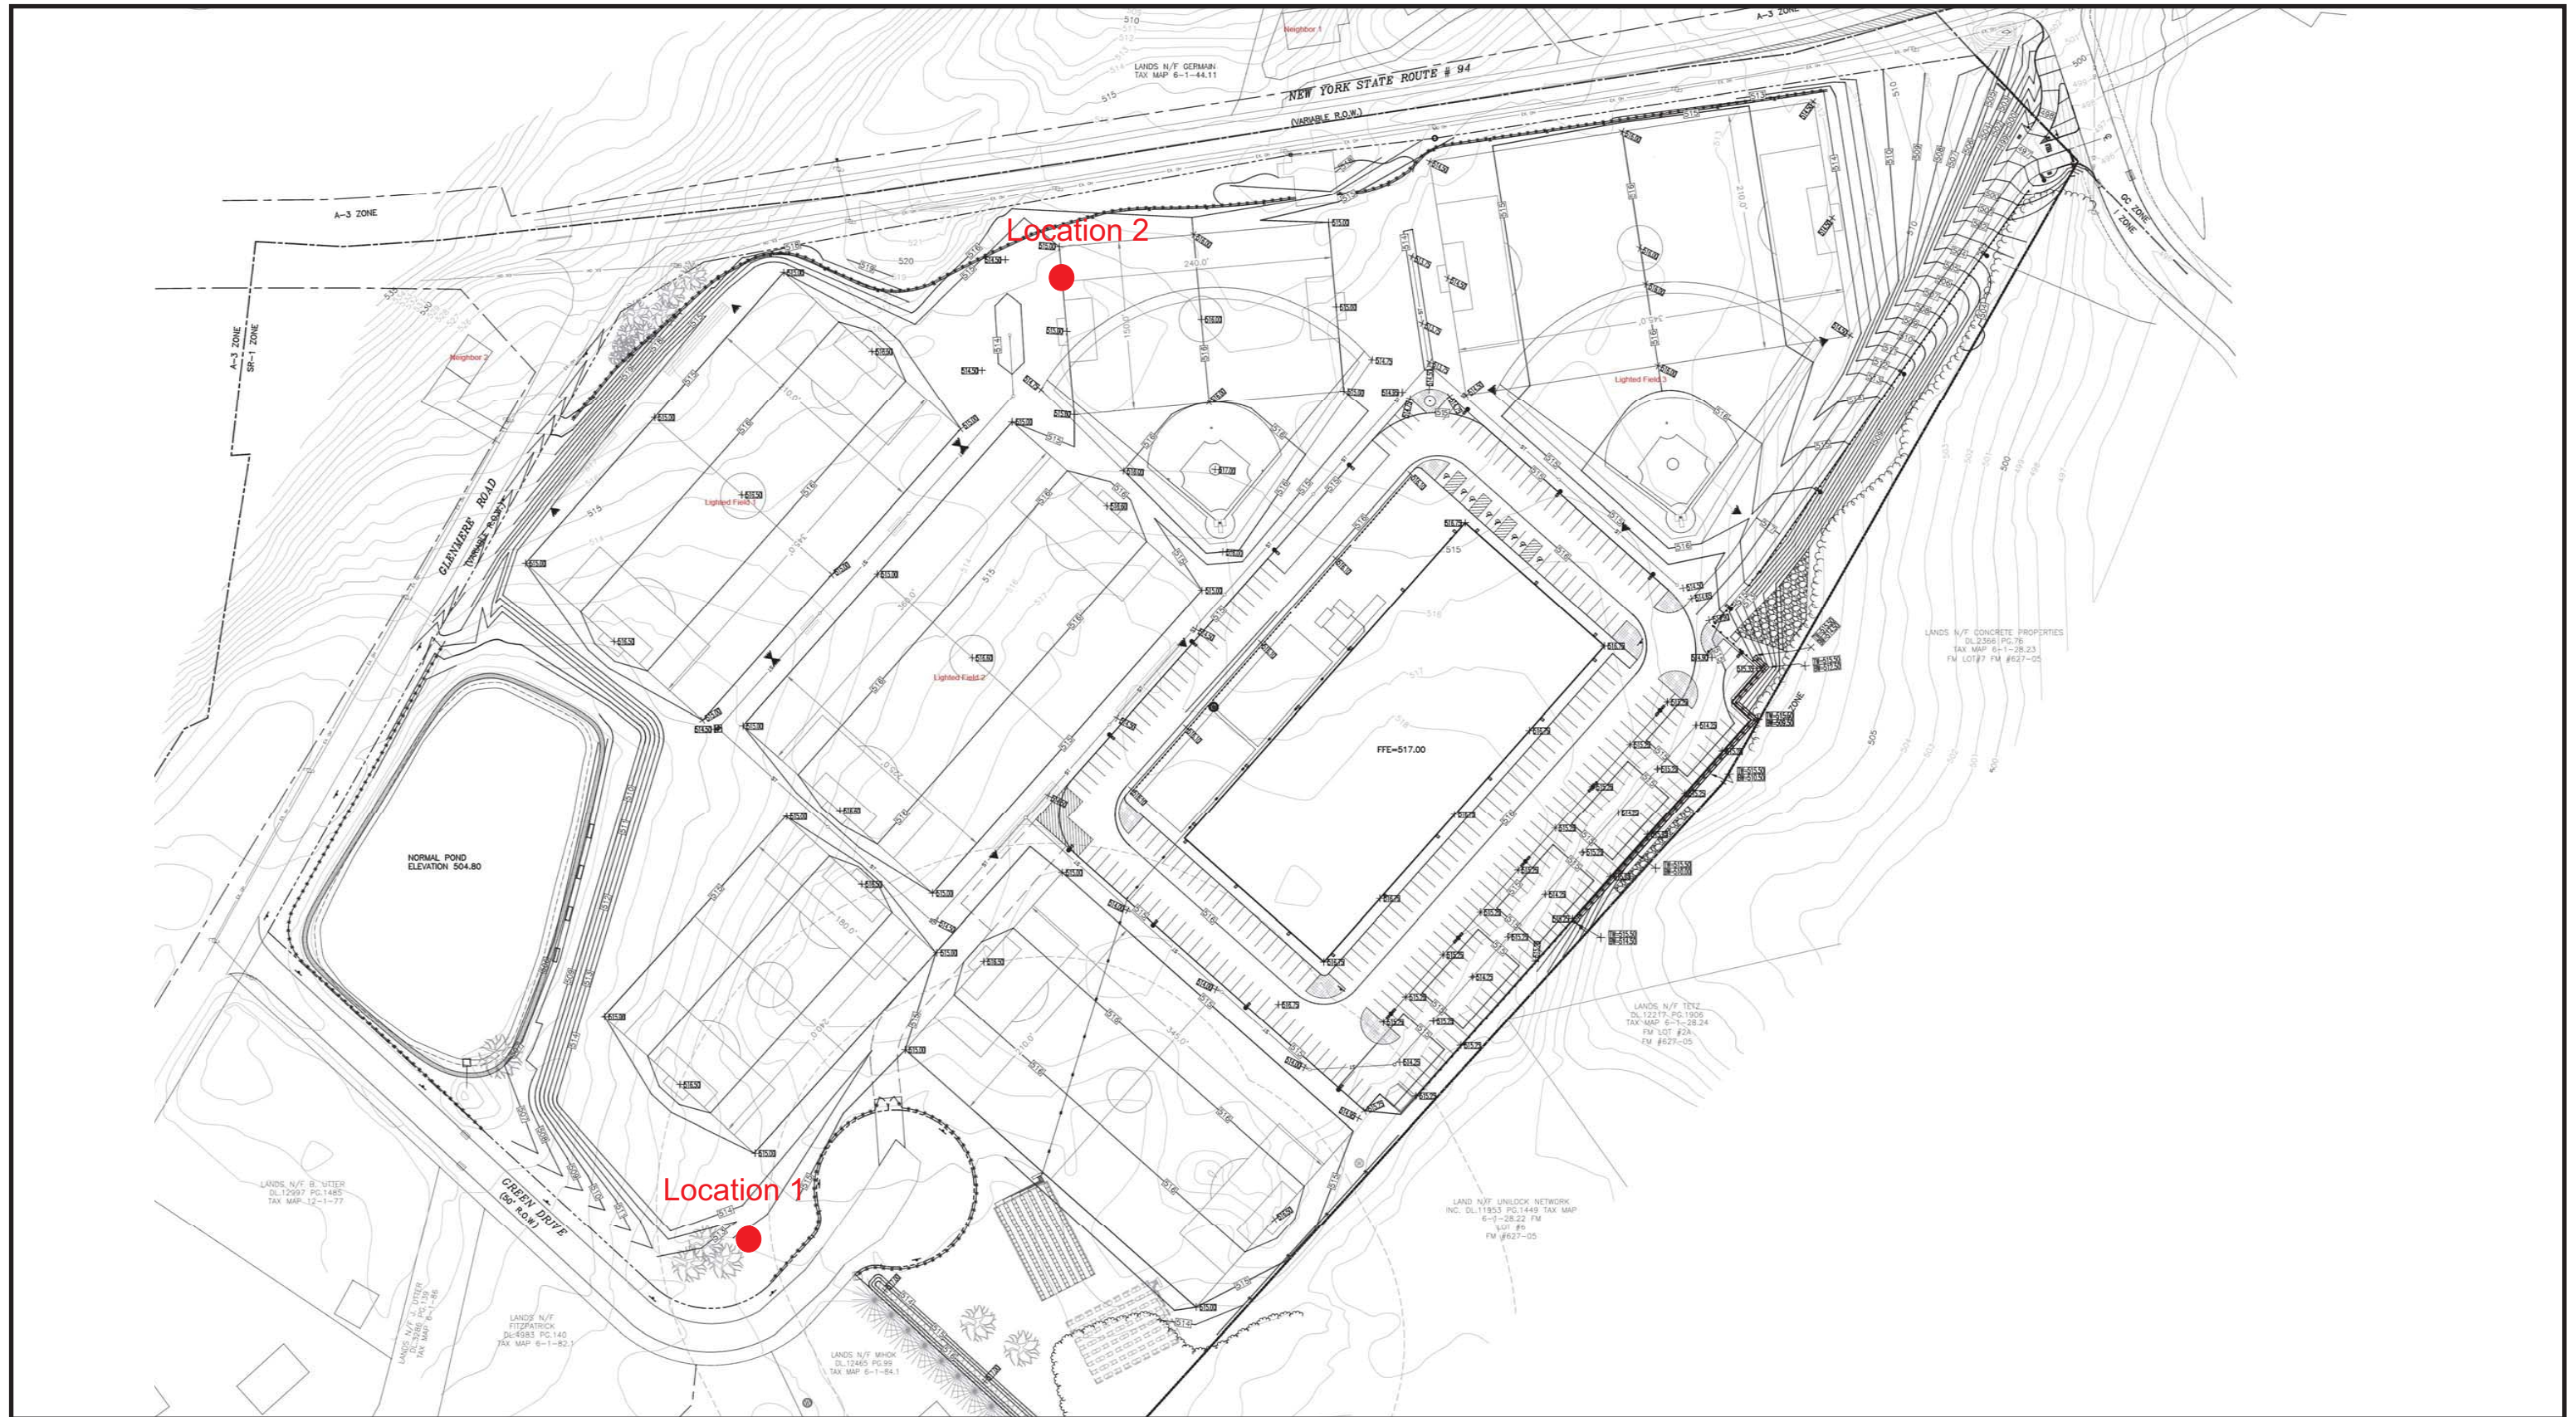
Figure 1: Primo Sports Property  
Noise Monitoring Locations  
Town of Chester, Orange County, New York  
Source: Fellenzer Engineering, LLP

Ambient noise measurements were collected at the Primo Sports facility on June 19, 2015. Location 1 was near the Green Drive cul-de-sac, approximately 50 feet northeast from Green Drive. This location provides the ambient noise conditions for residents of Green Drive. Location 2 was 75 feet south of Route 49 in the approximate center of the property. This location was selected to provide ambient noise conditions for residents near Route 94, and to reflect the existing traffic noise on Route 94. The two noise monitoring locations are shown in Figure 1 on an aerial photograph of the area.

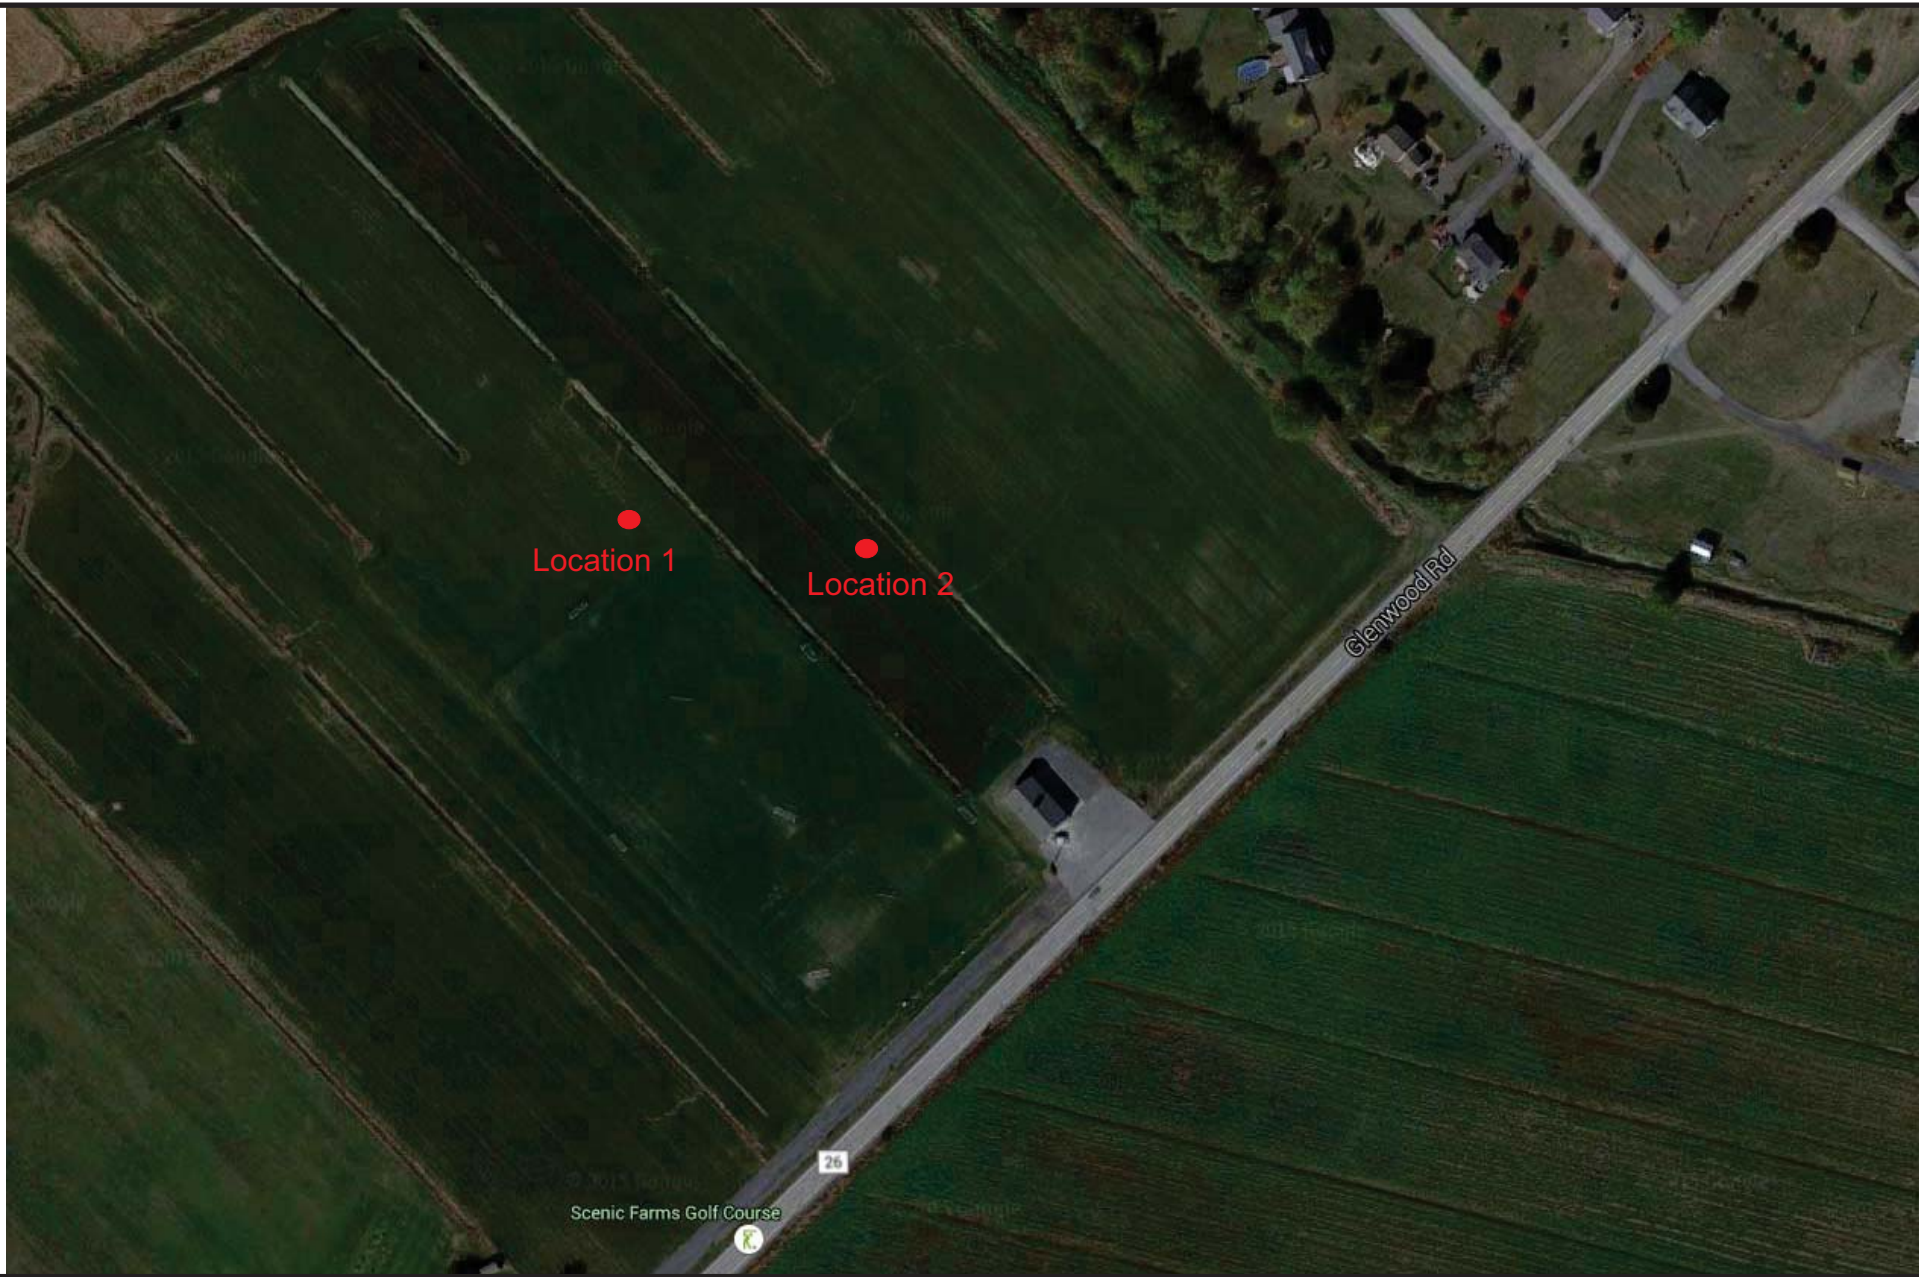
Figure 2: Pine Island Sports Facility  
Noise Monitoring Locaitons  
Town of Pine Island, Orange County, New York  
Source: Google Maps

Noise monitoring Location 1 was approximately 20 feet from the edge of the soccer field, and location 2 was 150 feet northeast from the edge of the field. Monitoring locations are shown in the aerial photograph, Figure 2.

Noise measurements were collected on June 13, 2015 at the Primo Sports facility, 547 Glenwood road, Pine Island, New York. The soccer facility is an open field surrounded by agricultural fields and with a golf range to the southwest. A small subdivision of homes is located northeast of the fields. Glenwood Road borders the property to the southeast.

and game periods (52 dBA). The pre-game and game noise levels at the Pine Island site were generally consistent: 55 dBA at Location 1 near the field and 52 dBA at a location 150 feet from the field. These results may be influenced by the moderately windy conditions before and during the game and the fact that the field is open and there are no structures to reflect sound.

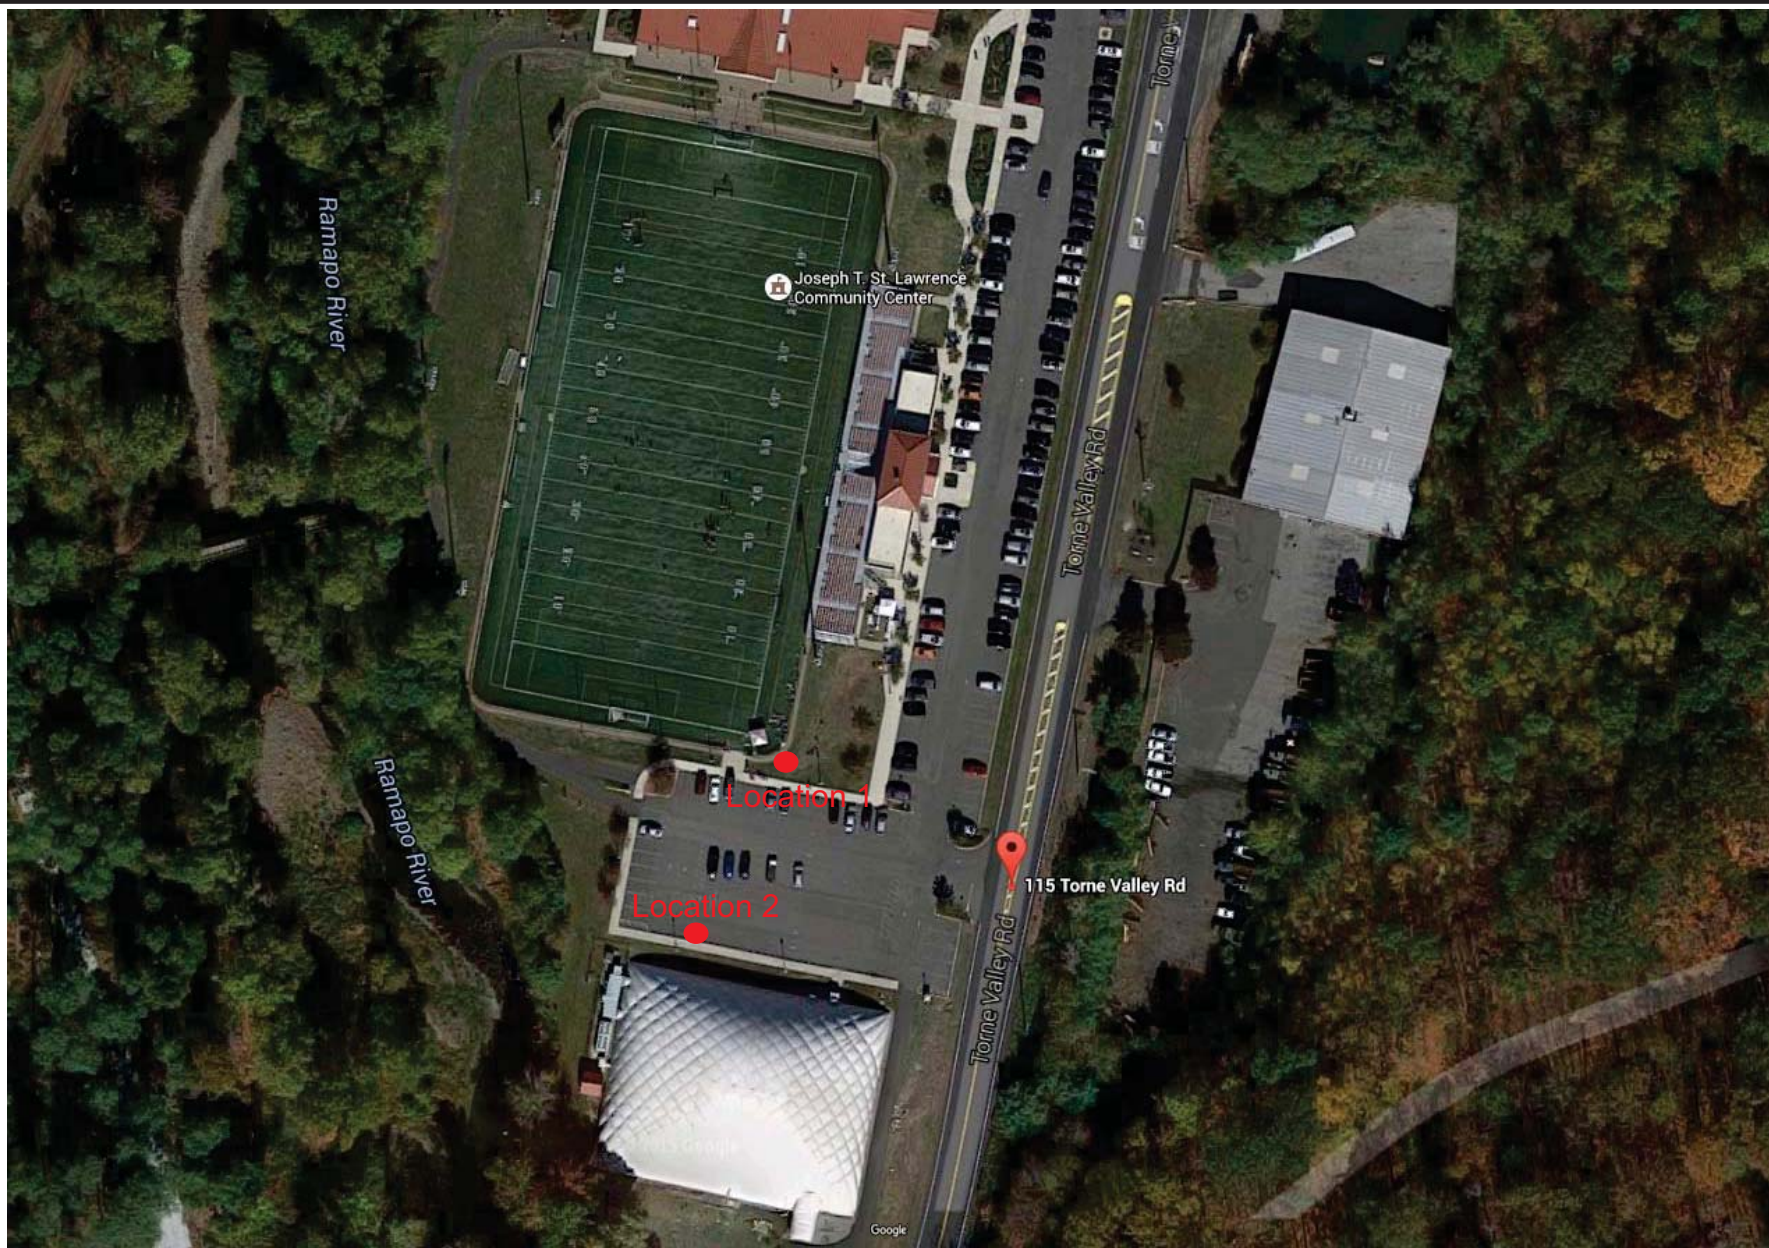
Figure 3: Torne Valley Sports Facility  
Noise Monitoring Locations  
Town of Hillburn, Orange County, New York  
Source: Google Maps

Noise monitoring Location 1 was approximately 20 feet from the edge of the soccer field, and location 2 was 150 feet south from the edge of the field. Monitoring locations are shown in the aerial photograph, Figure 3.

Noise measurements were collected on June 16, 2015 at the Torne Valley Sports Complex, 115 Torne Valley Road, Hillburn New York. The sports facility is a stadium type facility with spectator stands on the eastern side, an indoor sports building and an indoor inflatable dome facility. Torne Valley Road borders the property to the east and Interstate 87 is located approximately 1,400 feet west of the property. Some traffic noise from Interstate 87 was audible during the measurement period.

At the Torne Valley sports facility, the pre-game noise levels at location 1 near the field were 55 dBA and the level 150 feet from the field (Location 2) was 52 dBA. During the game the level increase to 62 at Location 1 and 57 at Location 2. This is an increase in noise of 6 dBA immediately next to the field and 5 dBA 150 feet from the field. It should be noted that the Torne Valley facility is unlike the Pine Island site and the proposed Primo Sports Chester site in that the field is surrounded on three sides by buildings and pavement. These hard surfaces reflect and amplify sound from the field. In addition, noise monitoring Location 2 was near a structure and across a paved parking lot from the soccer playing field. According to the Federal Highway Administration (FHWA) guidance, sound decreases less over paved surfaces than compared to soft ground or grass surfaces. For example, sound from a highway decreases 3 dBA for each doubling of distance from the noise source over paved surfaces. Over grass or soft ground the most suitable drop-off rate is 4.5 dBA per distance doubling<sup>1</sup>.

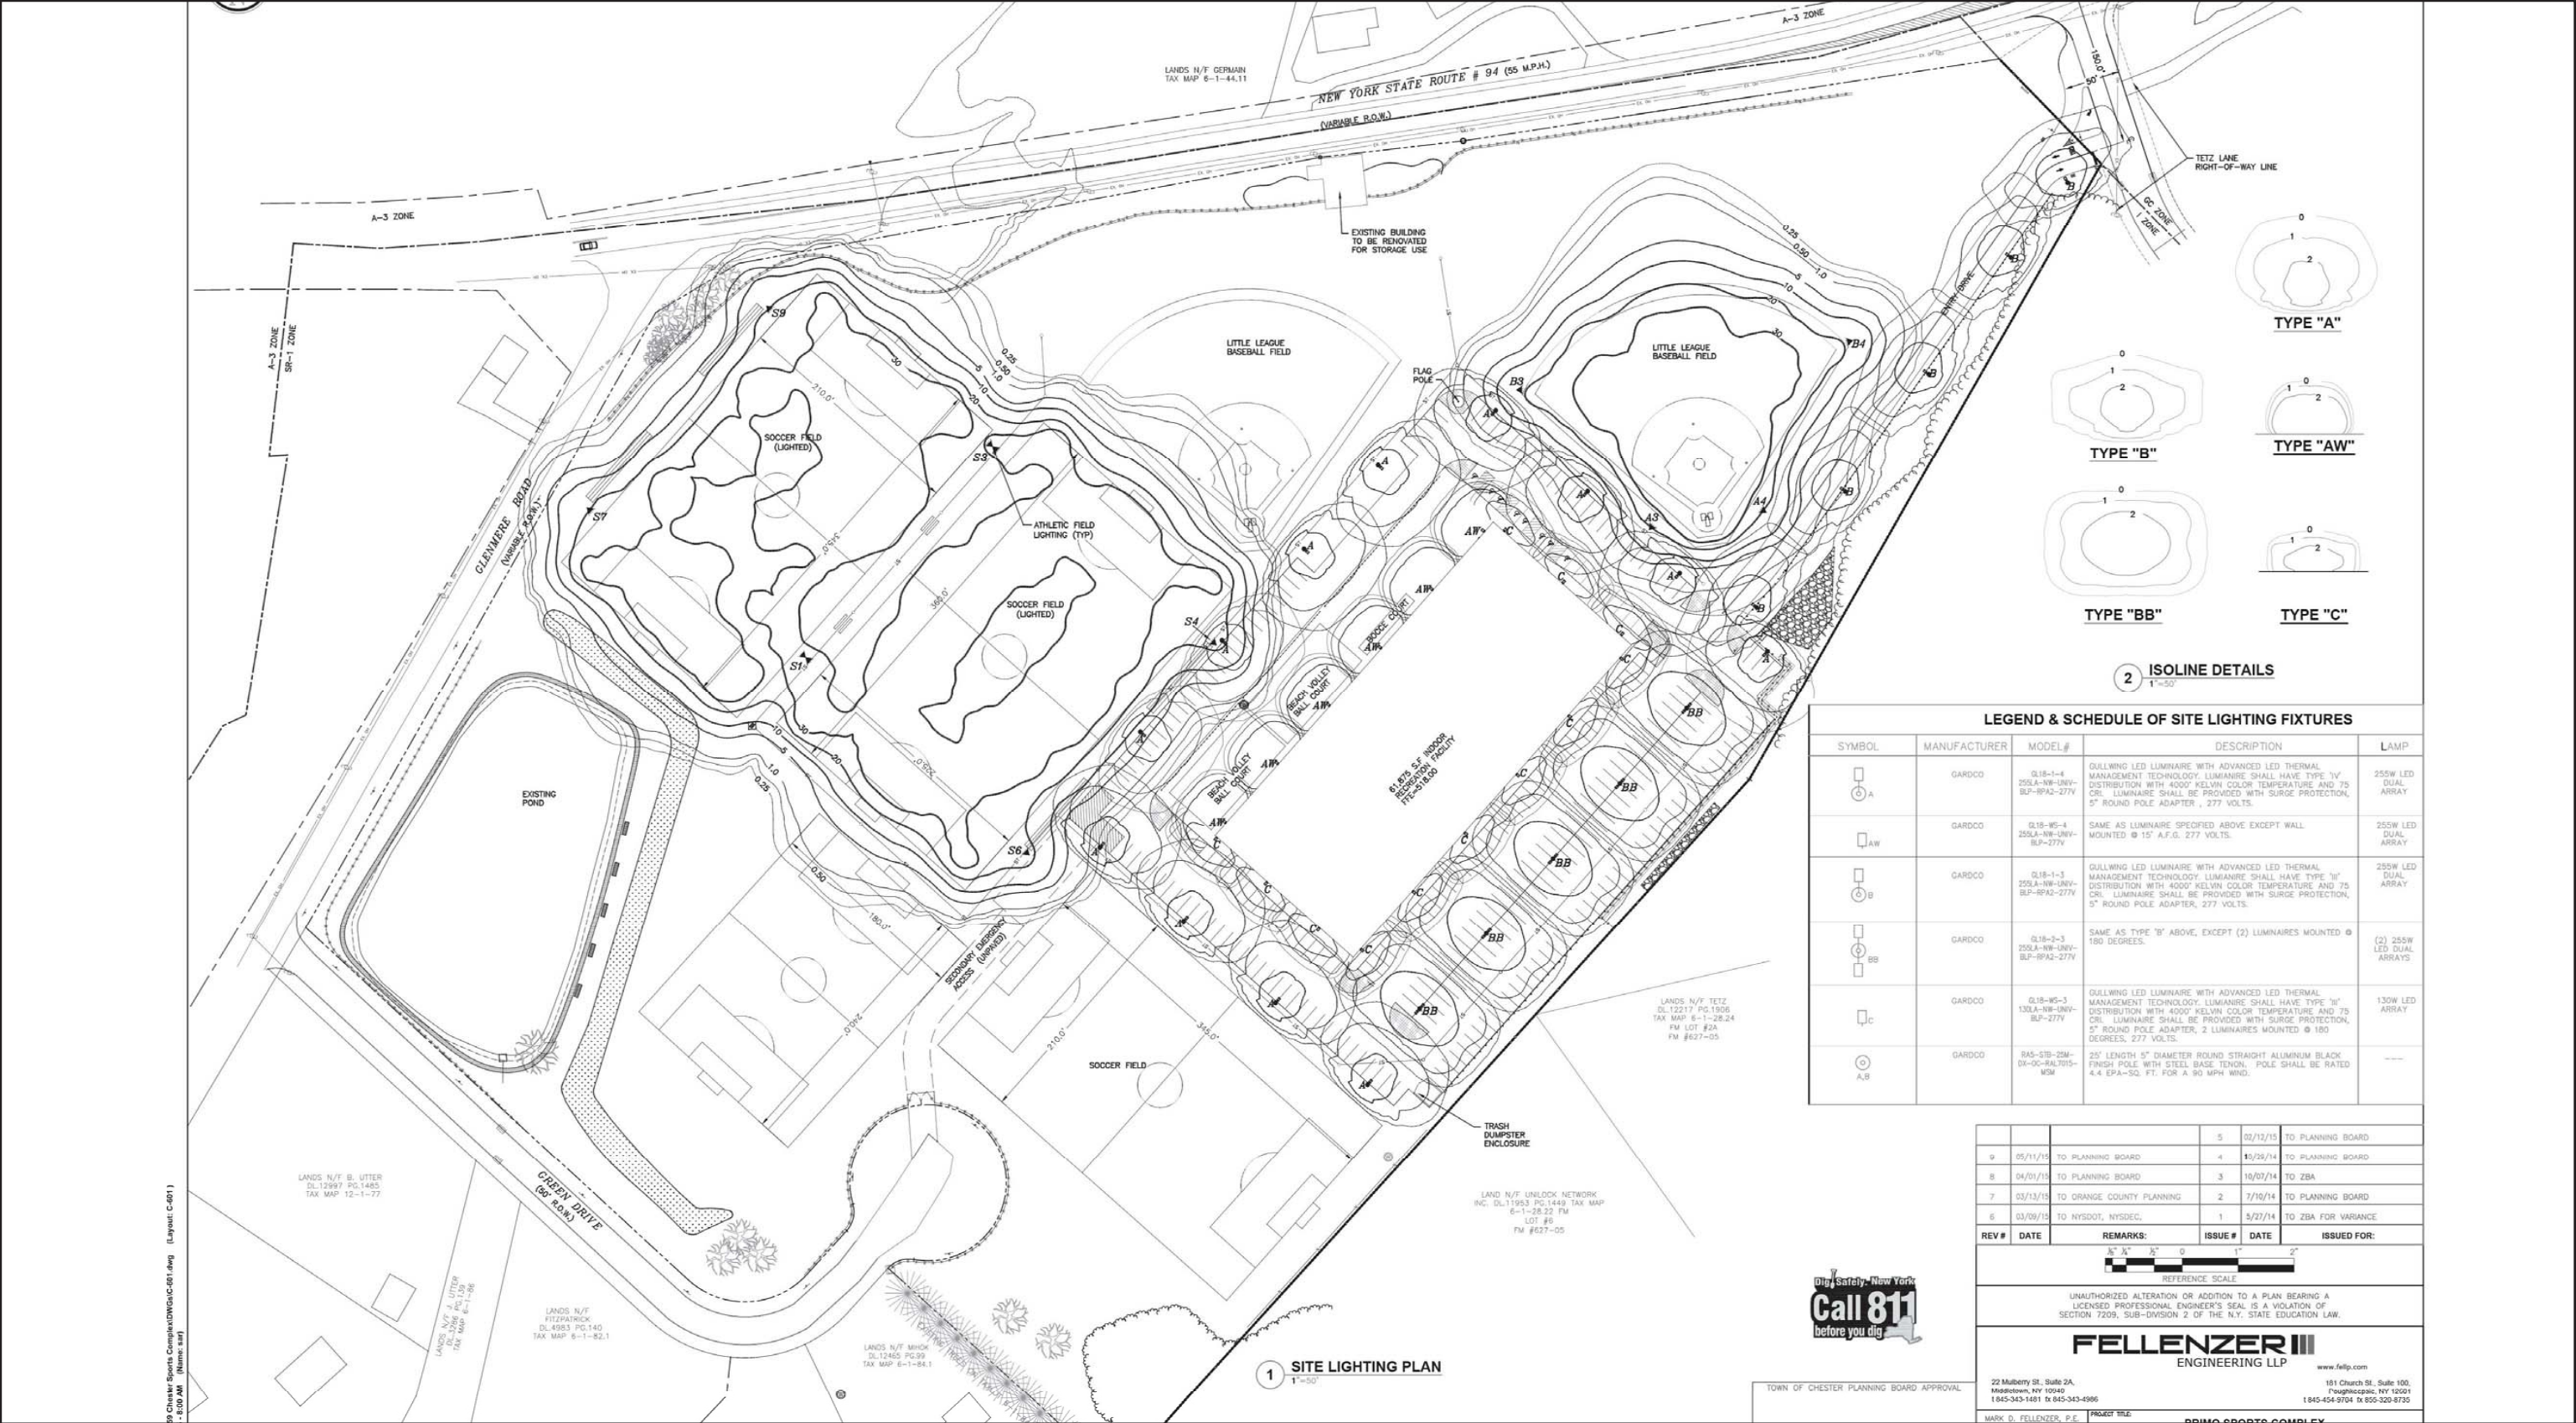
Figure 4: Lighting Plan  
Primo Sports Property  
Town of Chester, Orange County, New York  
Source: Fellenzer Engineering, LLP

The Lighting Plan provides a schedule of lighting fixtures, fixture type, pole height and pole location. The Plan also provides projected light isolines, which indicates the relative brightness of the lighting and the edges of the lighted field. The applicant is proposing Musco, "Green" LED fixtures. These fixtures provide the ability to precisely focus the light onto the field avoiding light "spill-over" or light extending off of the property. Specifications for the Musco lighting is provided in Attachment B, as well as photographs of lighting on an existing field. The LED lights are the latest technology in sports lighting and allow actual lowering of the lighting level, if needed.

As shown in the plan, no light will be projected towards the southern portion of the property or towards Green Drive. Light spill-over is generally avoided along the northern property boundary, or Route 94. Relatively low levels of light (1.0 foot-candles) will extend off the property and onto Glenmere Road in the northwest portion of the site. By comparison, the fields have lighting up to 30 foot-candles. No lighting is projected to extend onto neighboring private properties bordering the northwest portion of the site or bordering the southern portion of the site near Green Drive. As shown in the photos of the Torne Valley Sports Complex (see Attachment B), the glare from the lighting fixtures is only visible on the field or immediately next to the field. Project neighbors will see the reflected light (glow) from the lighted field but the lighting is designed to eliminate any glare when viewed from the residences or adjoining roads.

A detailed lighting plan has been developed for the Primo Sports facility. The lighting plan provides a schedule of lighting fixtures, fixture type, pole height and pole location. The plan also provides isolines to show the level of lighting on the fields and at the edges of the project site. The proposed lighting for the Primo Sports facility is further described below.

A detailed lighting plan has been developed for the site to provide both lighting for certain fields for nighttime play, but also safety lighting for the parking areas and building entrances. The lighting plan is provided as Figure 4. The two northern soccer fields and one little league baseball field will have lighting provided, while the southern two soccer fields and the north-central little league baseball field will not be lighted. Lighting will be provided for beach volleyball, and bocce courts at the northwest side of the recreation building.

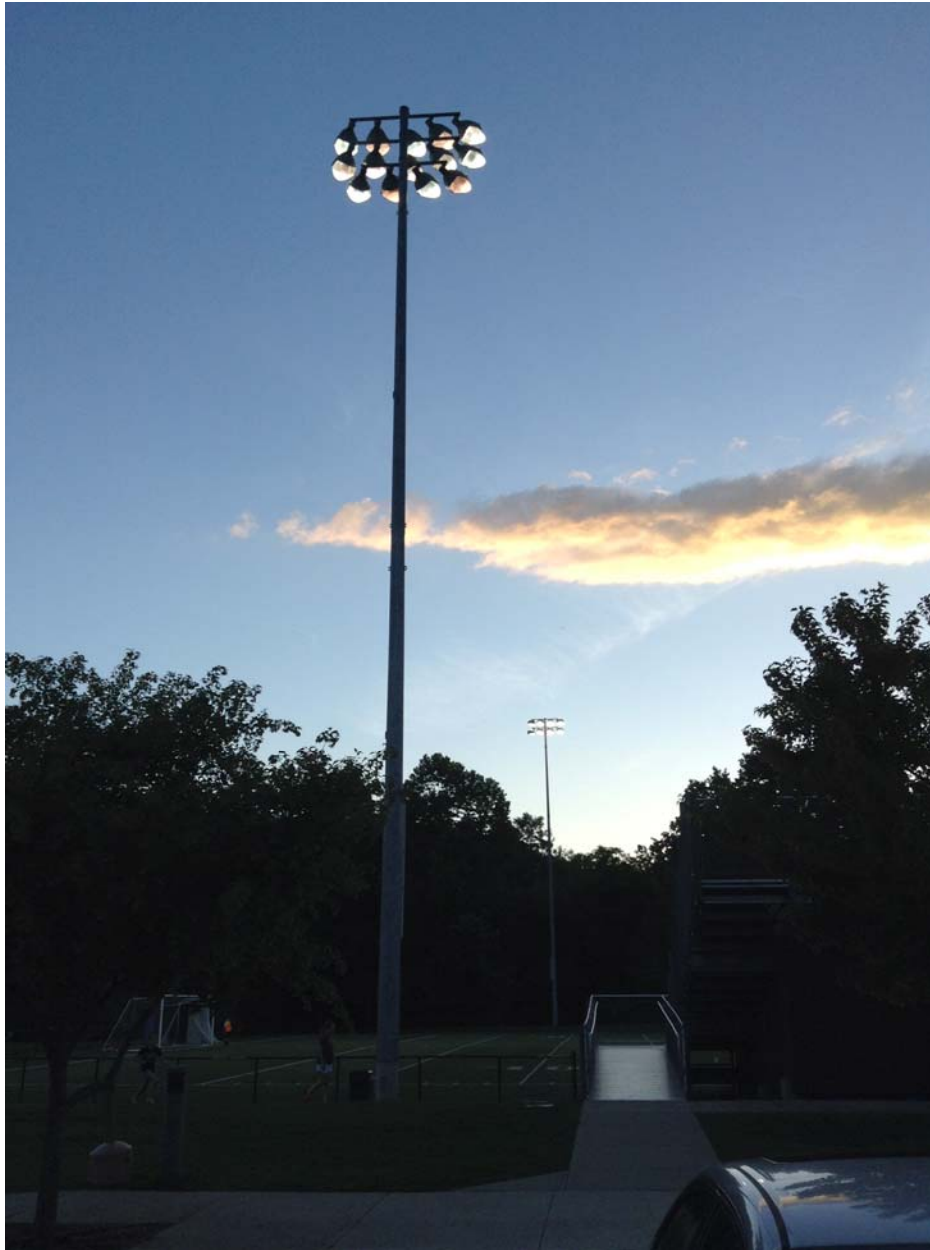
- 1) View of Musco lighting poles at the Torne Valley Sports facility, facing west.

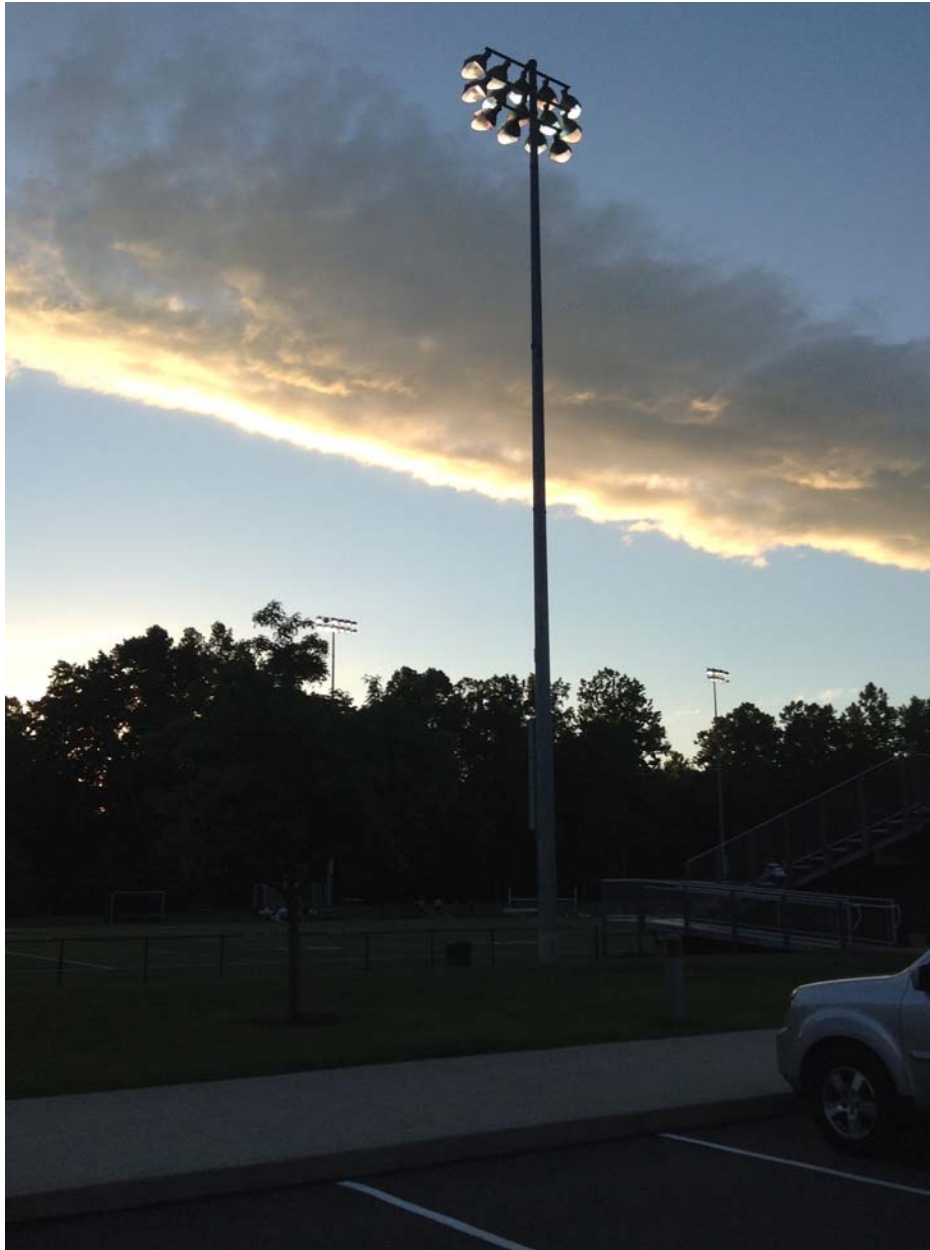
- 2) View of lighting poles, facing northwest. Note lack of glare from fixtures, in foreground and background light fixtures.

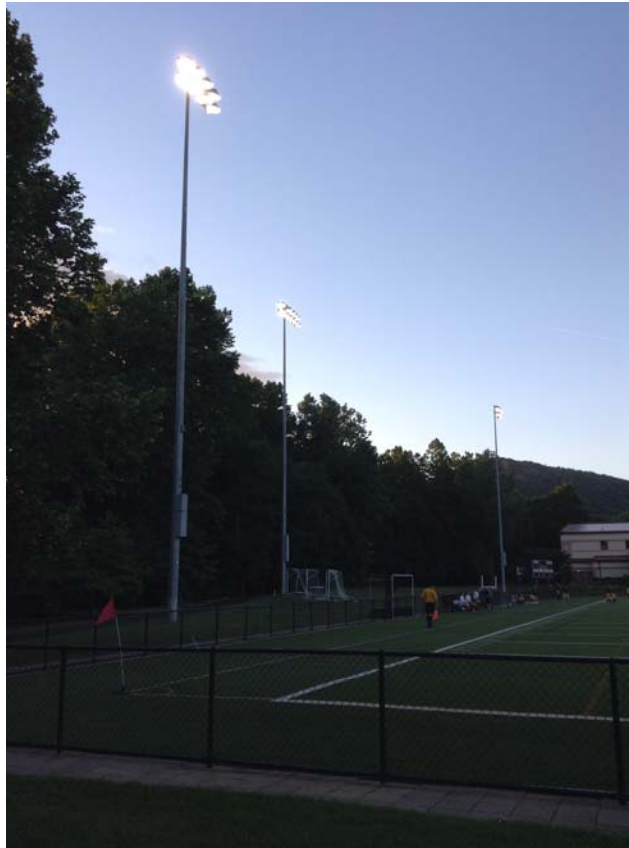
3) View of field lighting, facing north. Note fixture light is visible under fixture.

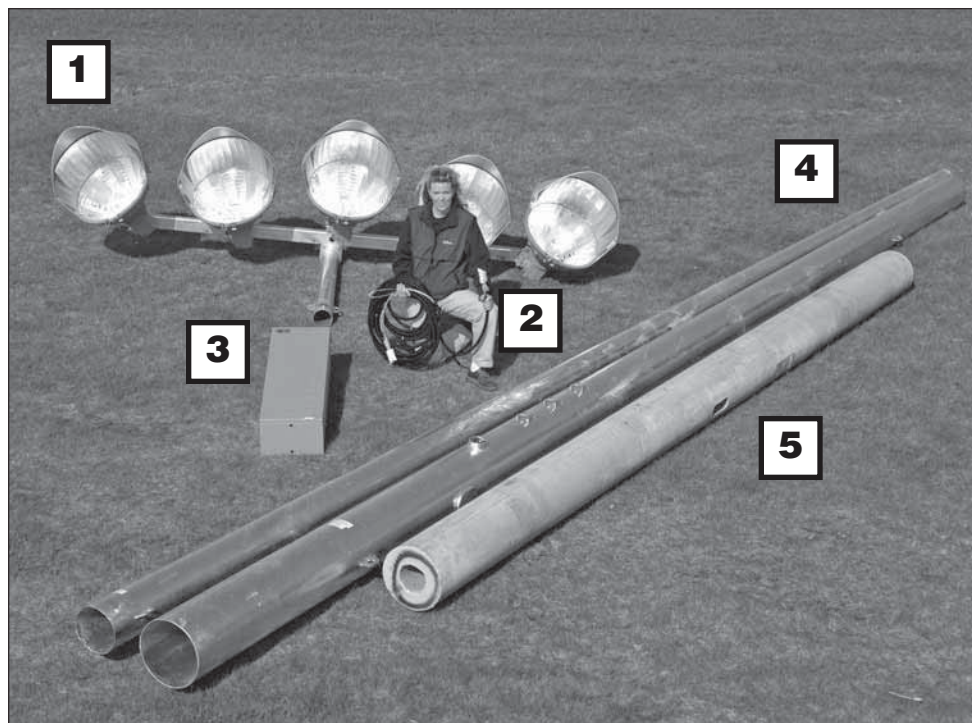
# Light•Structure GREEN™ ...in 5 Easy Pieces™

**1** Poletop Luminaire Assembly

**2** Wire Harness

**4** Galvanized Steel Pole

**5** Precast Concrete Base

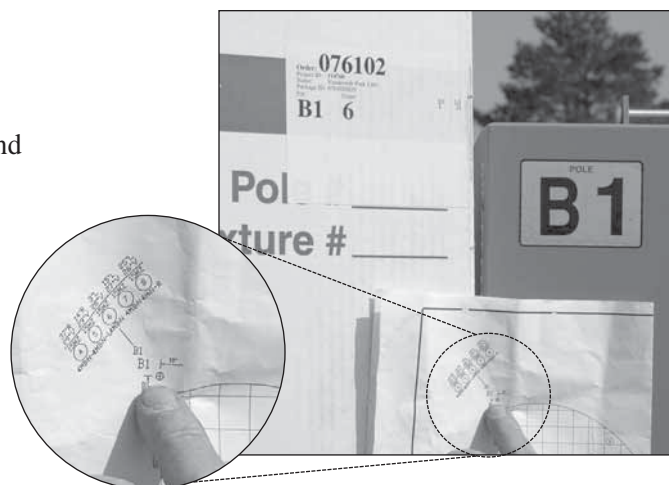
Light-Structure Green pole locations are identified by a letter-number combination (A1, A2, B1, B2, etc. — see photo at right) on the Field Aiming Diagram and each of the 5 Easy Pieces for each pole's location:

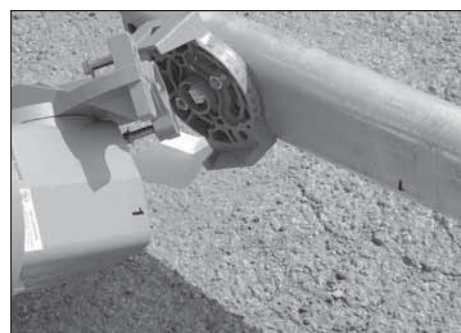
Luminaires will be individually labeled, identifying the correct crossarm location (see photo at right.). The luminaire comes completely assembled. Each luminaire is also identified on the Field Aiming Diagram.

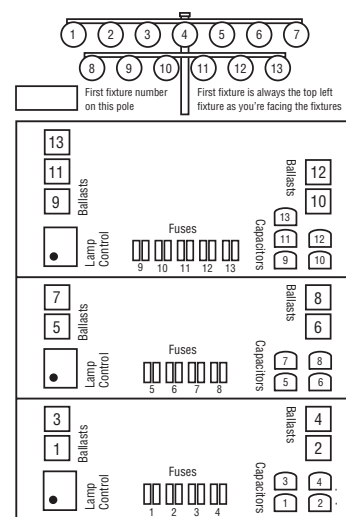
Typical fixture location diagram

Ballasts, capacitors, fuses and fixtures are each labeled with a number that corresponds to the luminaire's location on the Field Aiming Diagram. (See typical fixture location diagram.)
